The Last Straw

– Failure of wood structure as mushroom composting facility

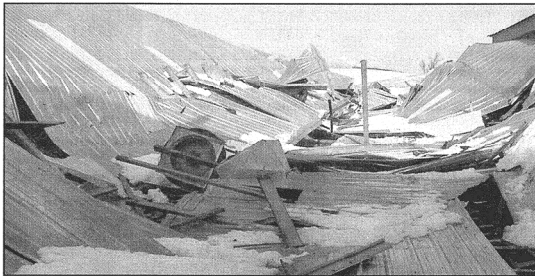
The "Straw Farm", an 18,000 square foot mushroom composting facility on South Parallel Road in Abbotsford, BC, collapsed at the end of January due to failure of the wood truss roof system. It had been in use for less than 5 years.

Close inspections of the galvanized metal truss plates show an advanced stage of corrosion. The bottom chords of the light weight wood trusses, operating under tension, became separated, and a little sprinkling of light snow, was the proverbial "straw that broke the camel's back", causing

the trusses to fall to the floor and imploding the entire structure.

These problems beg the question. Is it possible to safely use wood frame buildings for composting purposes? At the very least the metal connector plates should be protected with a special coating as recommended by the Truss Plate Institute of Canada. Such coatings, usually brush applied, consist of specially formulated epoxies, coal-tar, or asphaltic mastic paints. At best such treatment may extend the serviceable life of the truss connector plates, but an ongoing building maintenance program is needed to ensure continued protection. Even though such protective treatment is recommended, it is often neglected.

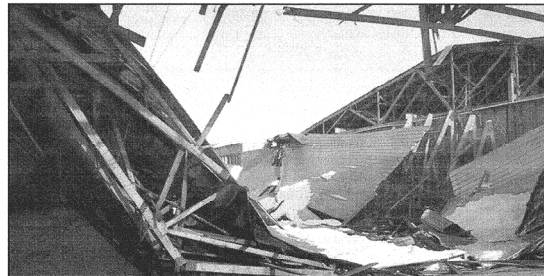
Corrosion of truss plates

The Straw Farm had a substantial amount of air inlets on both sides of the building, and the front of the building was fully open. In spite of this the problem developed to the point of total failure.
