When All Galvanizing is NOT the Same!

In 2002, due to the corrosion of galvanized truss plates on a wood frame composting facility in Abbotsford BC, a building collapsed, just five years after being newly constructed.

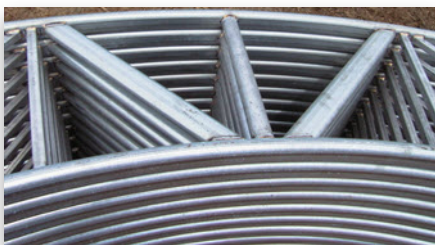
Pre-galvanized, welded steel truss frame by a competing supplier, shows inside rust.

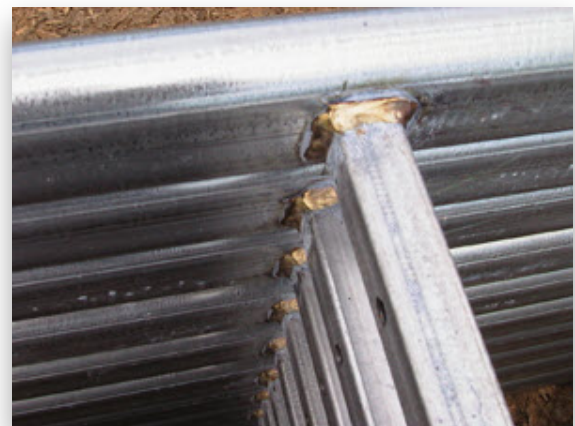
Pre-galvanized steel tubing with silicon bronze welding only available on Megadomes - No joint rust!
